SSI #4, #14 PROBLEMS AND SOLUTIONS

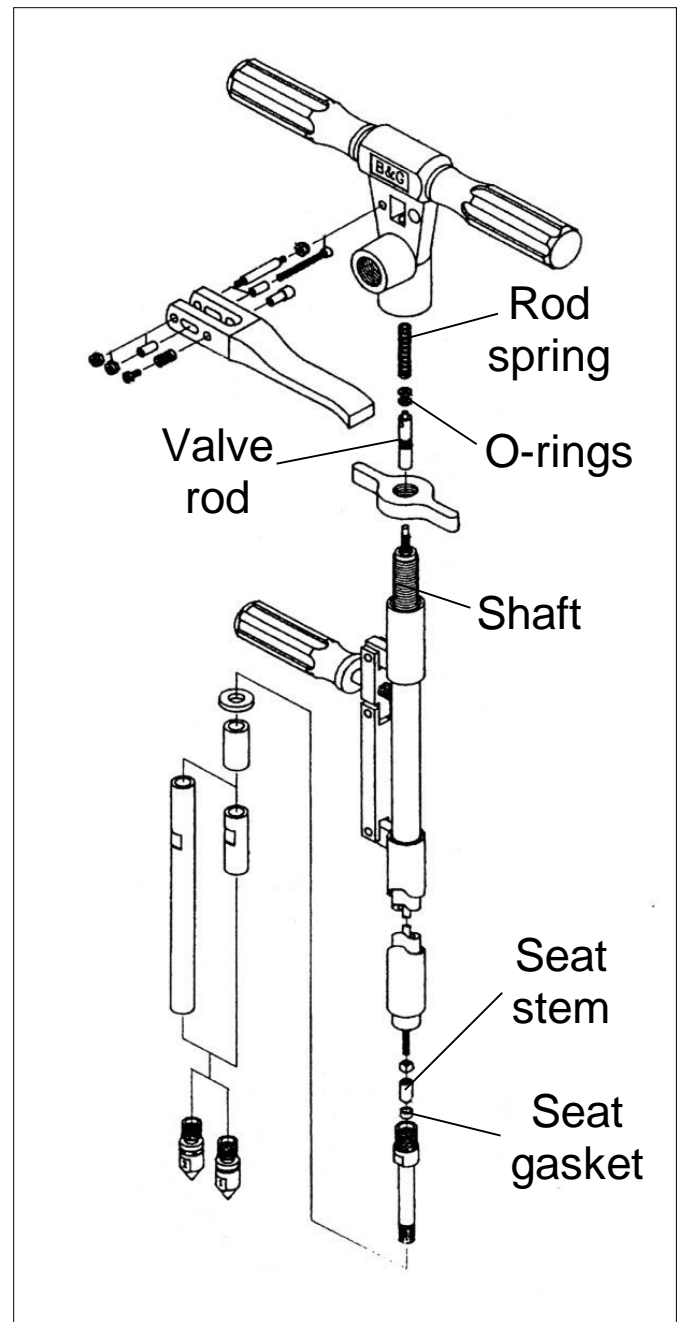
P. Tool is leaking from the tip or just above.

P. Leaking occurs around the rod spring connection to the Valve.

P. Leaking occurs around the pipe connection to the valve.

S. Tighten tip with a wrench.

If tool continues to leak, replace the seat gasket (#22071977).

If tool continues to leak from the tip, check the seat stem and replace if damaged (#22071976).

S. Remove the pipe at the wing nut and disassemble the valve to free the rod spring. Replace the 2 O-rings in the valve rod.

S. Tighten the pipe into the valve body.
